Re: Roof Assessment Report
 Village on the Bayou Inc. v. State Farm Fire & Casualty Insurance Co.
 515 Lincoln Road
 Monroe, LA 71203
 Carrier Claim No.: 18-04N7-70F
 Date of Loss: April 13, 2019
 Policy No.: 98-BR-D158-9
 KWA File No.: 07010-22-01

ROOF ASSESSMENT REPORT

VILLAGE ON THE BAYOU INC. v. STATE FARM FIRE & CASUALTY INSURANCE CO.

VILLAGE ON THE BAYOU
515 LINCOLN ROAD
MONROE, LA 71203

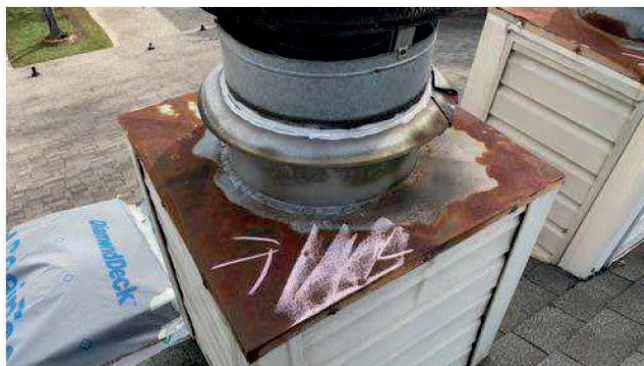
Photo taken from Page 29 of 35 of Exhibit No. 9

- 4) Hail damage to the metal roof panels of the parking structures, which affects the longevity and / or function of the metal panels, was not noted.
- 5) Chimney flue enclosures, sheet metal chimney enclosure cap flashings, and chimney flue caps exhibit minimal hail impacts with the majority of the enclosures, enclosure cap flashings and chimney flue caps not requiring replacement as a result of hail impacts. The enclosure cap flashings are deteriorated and rusted due to age and have not been adversely affected by hail. Conditions noted to the few flue caps dented by potential hail impacts does not affect the performance and/or function of the component.

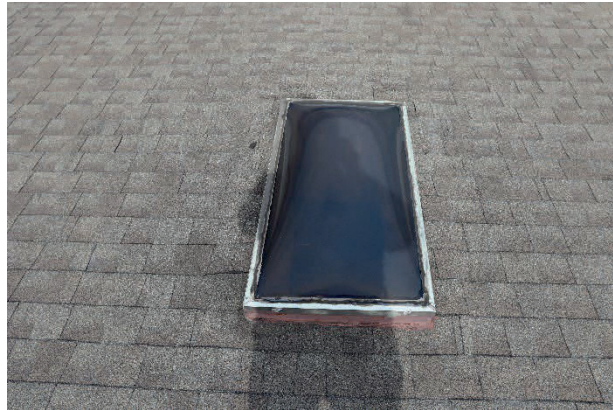
- 6) The skylights of the ten residential buildings and the Club House did not appear to have been damaged by hail. Cracks noted to skylight lenses appear to be related to age and deterioration with many cracks existing in the interior, rather than exterior domes of the skylights. Cracks to exterior lenses do exist; however, hail impacts to skylights which result

in fractures to domes are typically concentric in nature. Photographs of skylight conditions are furnished below.

KWA File Photo – June 7, 2022 – View of old sealant around perimeter of dome

- The replacement of skylights on each building with new skylights, as the result of hail impacts affecting the domes, is not needed as cracks to interior and exterior domes appear to be the result of age and deterioration and do not appear to be the result of hail. KWA does recommend replacement of the skylights should a re-roofing project proceed; however, this recommendation is due to the age and deterioration of the skylights and not due to hail impacts. Aguilar Construction Services provided estimates totaling \$79,698.12 for this work.

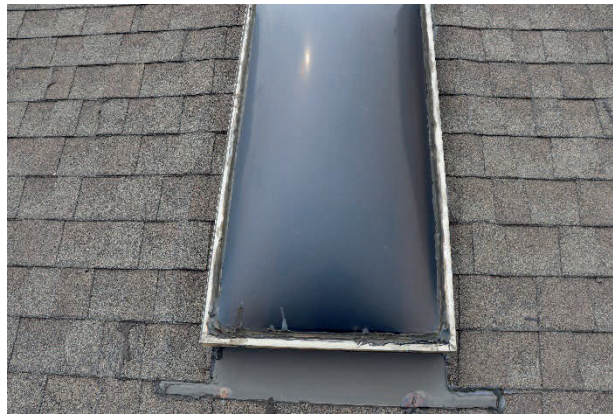
KWA File Photo – June 7, 2022 – View of old sealant around perimeter and over cracks in dome

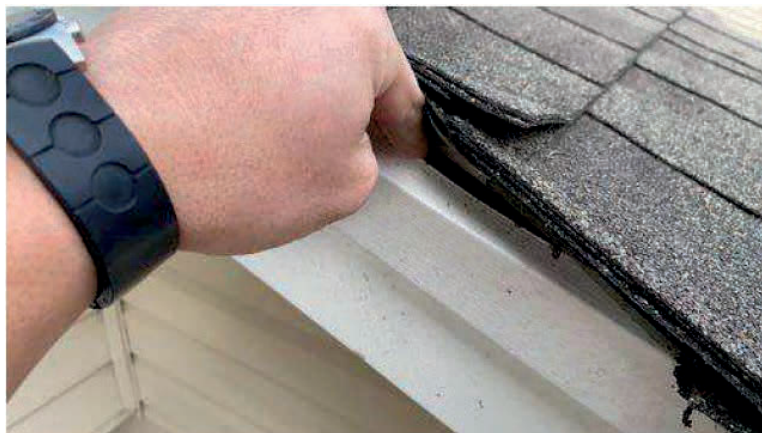
Photo taken from Page 34 of 35 of Exhibit No. 9

- The removal and replacement with new materials of the fascia conditions along the eaves and rakes is not required. The existing fascia metal turns onto the roof surface, beneath the shingles. The existing roof system can be removed without damaging the existing fascia metal and a new drip edge can be installed. Caulking is not required. Photographs of conditions are furnished below. Aguilar Construction Services provided estimates totaling \$420,739.33 for this work.
